Current Conditions at Neary

NEARY

BUILDING PROJECT

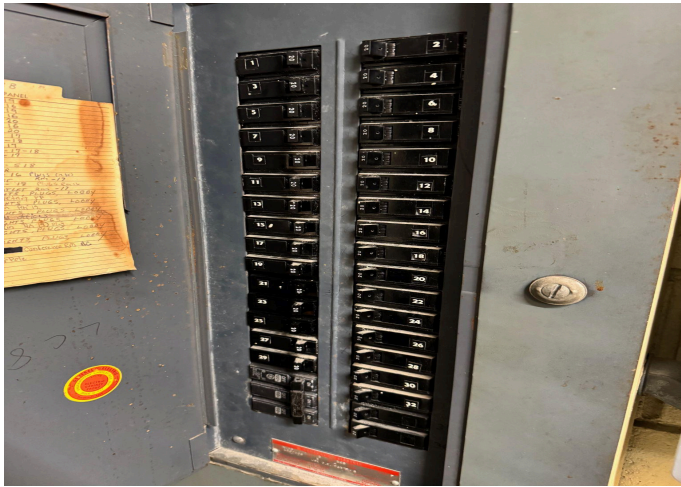
The electrical system is original to the 1970 construction. The system is at capacity and does not have enough capacity to handle any additional equipment.

Outdated Electrical System

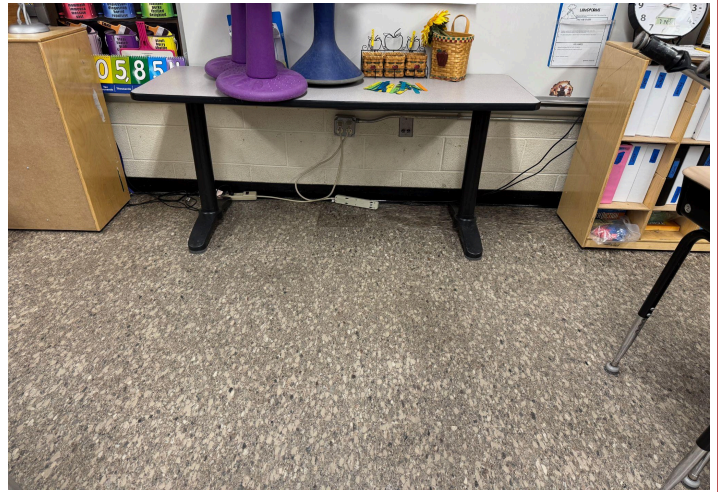
Limited Electrical Outlets

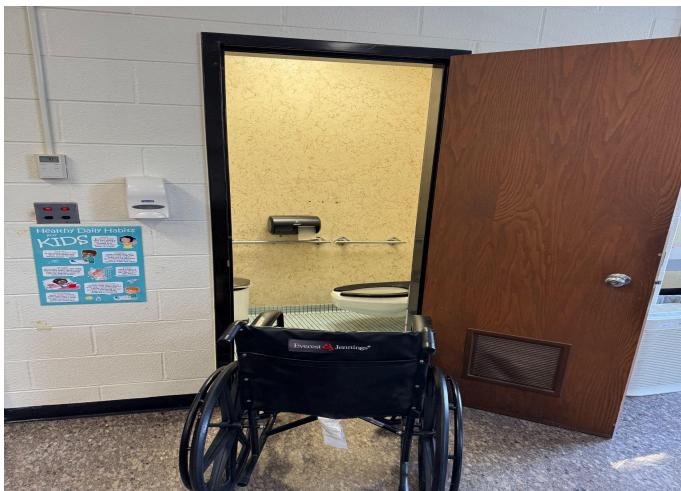
The current restrooms are not configured or sized for ADA compliance. The new building will have appropriate spacing and uninterrupted access to all fixtures.

Current Bathroom Access

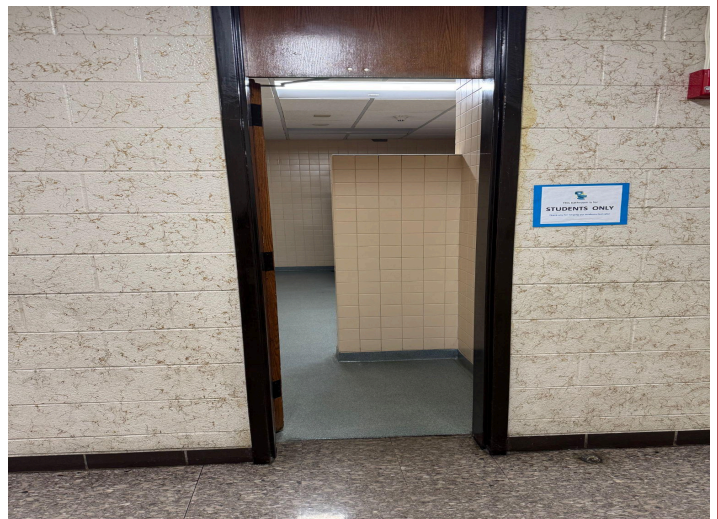
Doorway is 10" under code

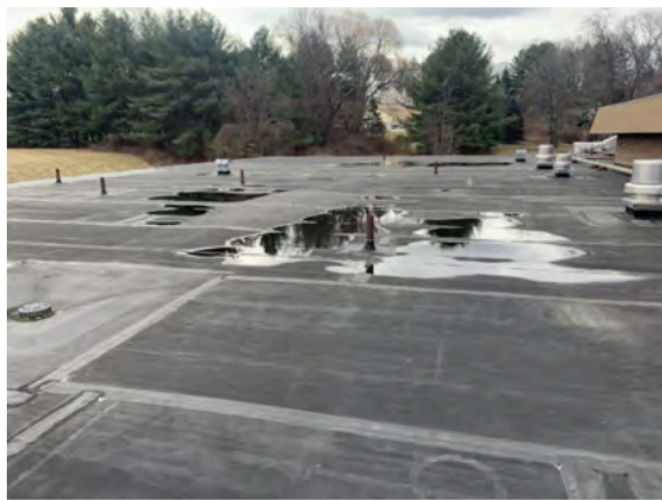
The roof is well beyond its expected life and currently experiences frequent leaking and seam failure. Each year, our Facilities Team is repairing the roof's most strained places - \$15,000 to \$20,000 a year.

Poor Drainage

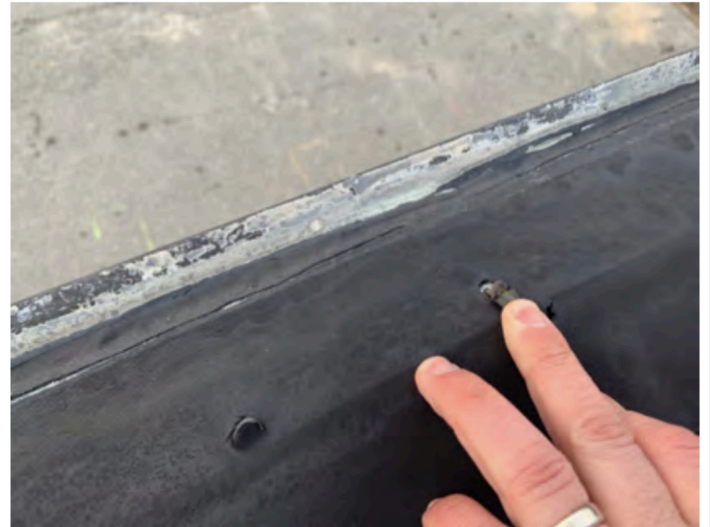
Failed Seams

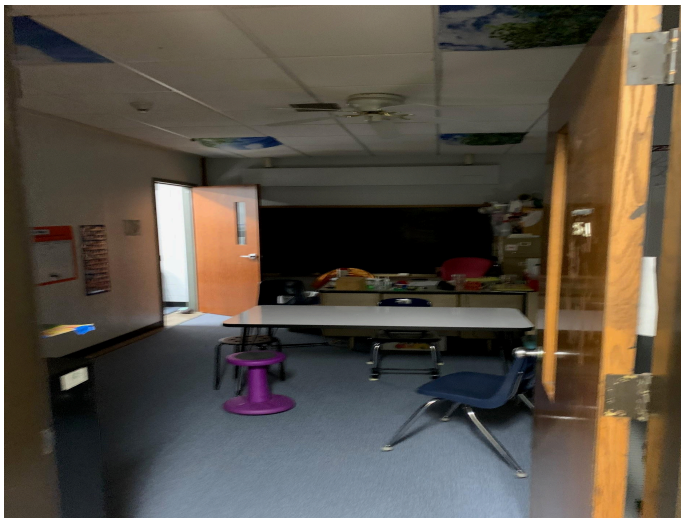
Many interior spaces, including the library, at Neary do not have natural light. These spaces are not conducive to quality learning and instruction spaces.

Interior Room

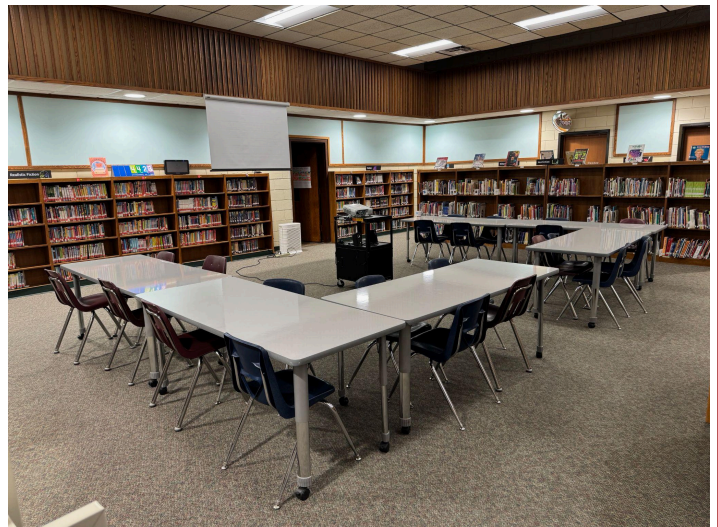
Library

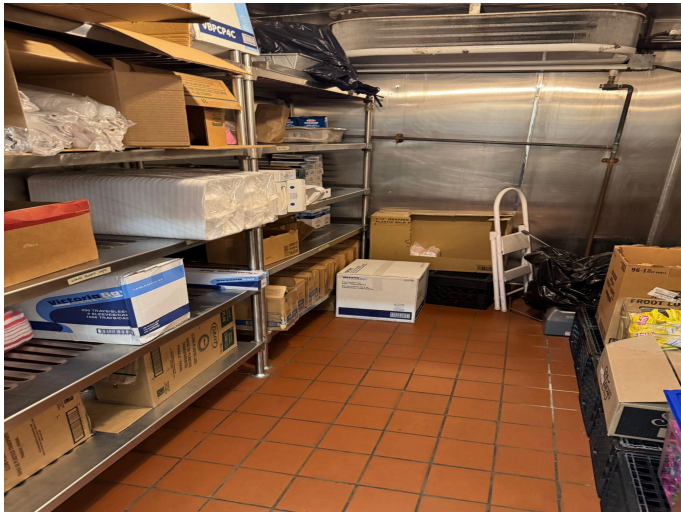
The kitchen does not have adequate storage for cooling and freezing food to support a full-service operation.

Walk In Cooler used as storage

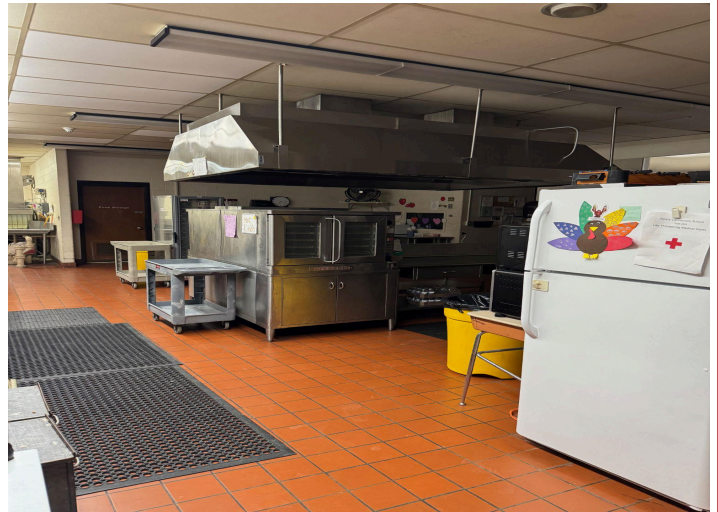
Limited Kitchen Equipment and Space

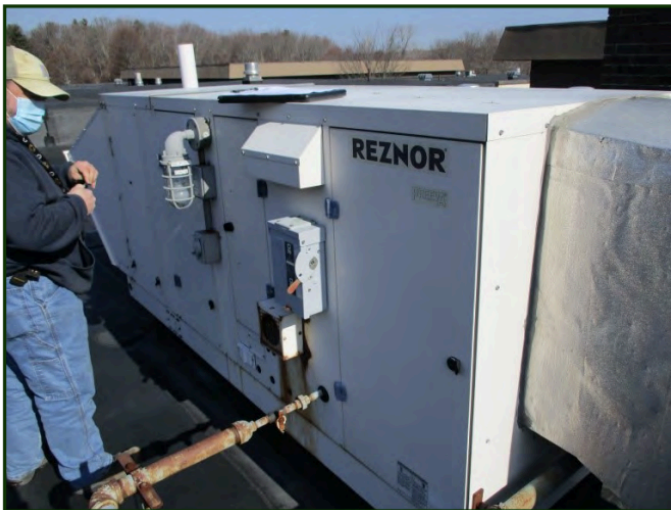
The current heating system is fragmented into different types and only portions of the building are supported by air conditioning. The new building will offer improved efficiency with a ground-sourced system for heating and cooling.

Current Rooftop Units

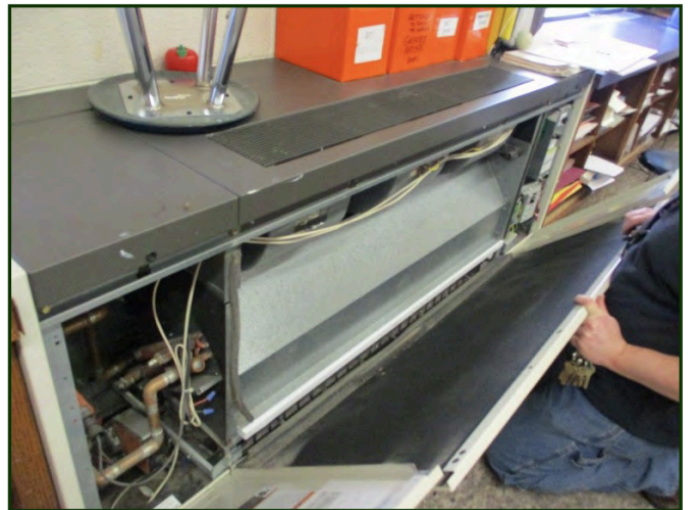
Current Classroom Univents

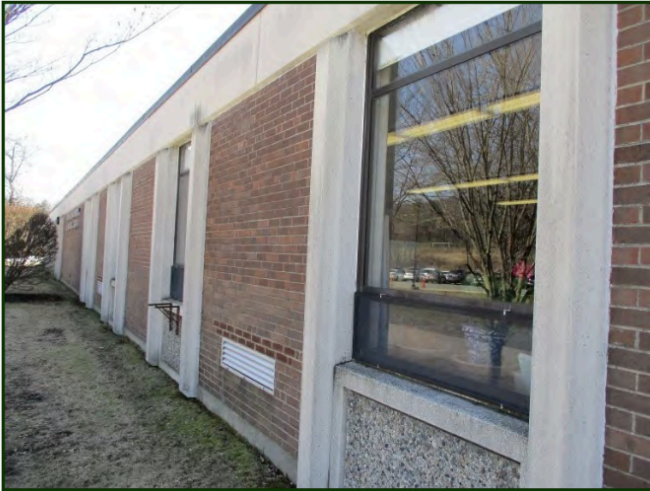
Although functional, all windows at Neary are original. They are single-paned windows that are inefficient and are a source of energy efficiency that will be gained with a new building.

Original Window Full View

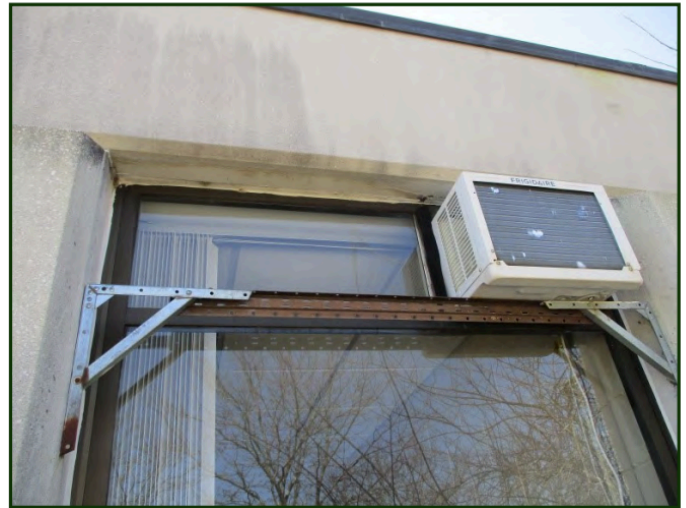
How air conditioning is achieved

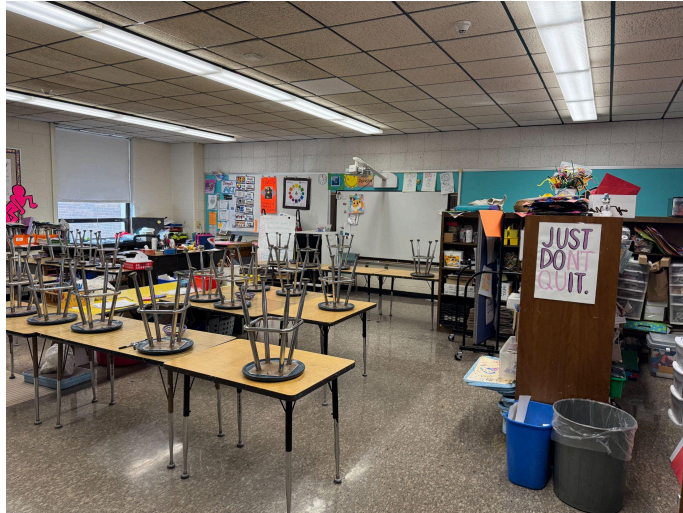
The current art room is a converted classroom with limited demonstration space and no storage or display area.

Current Art Room

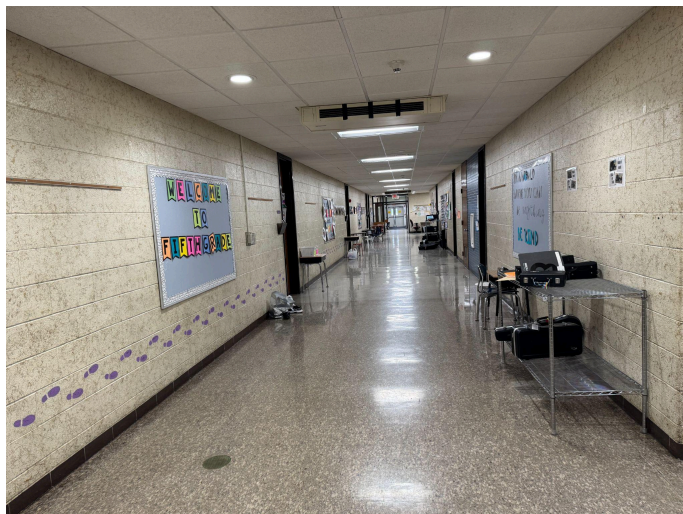
The current building does not offer adaptable extended learning space.
The new building will offer flexible seating and STEM learning spaces.

Current Hallway

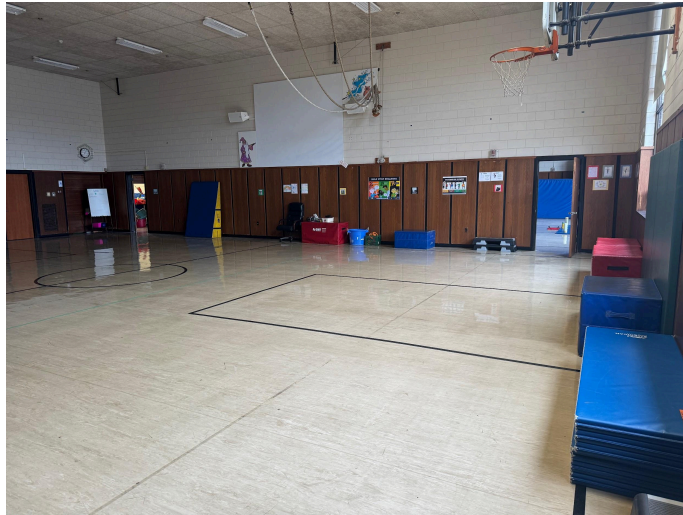
The current gymnasium is a split space with inadequate spacing and storage. The current gymnasium does not support current instructional or community needs.

Inadequate Storage / Split Gym
